# Uniform Mitigation Verification Inspection Form

| Owner Name: Plaza de Flores Condominium Association, Inc. | | Contact Person: Mark Habermann |
| Address: 4252 Central Sarasota Parkway (B.4) | | Home Phone: |

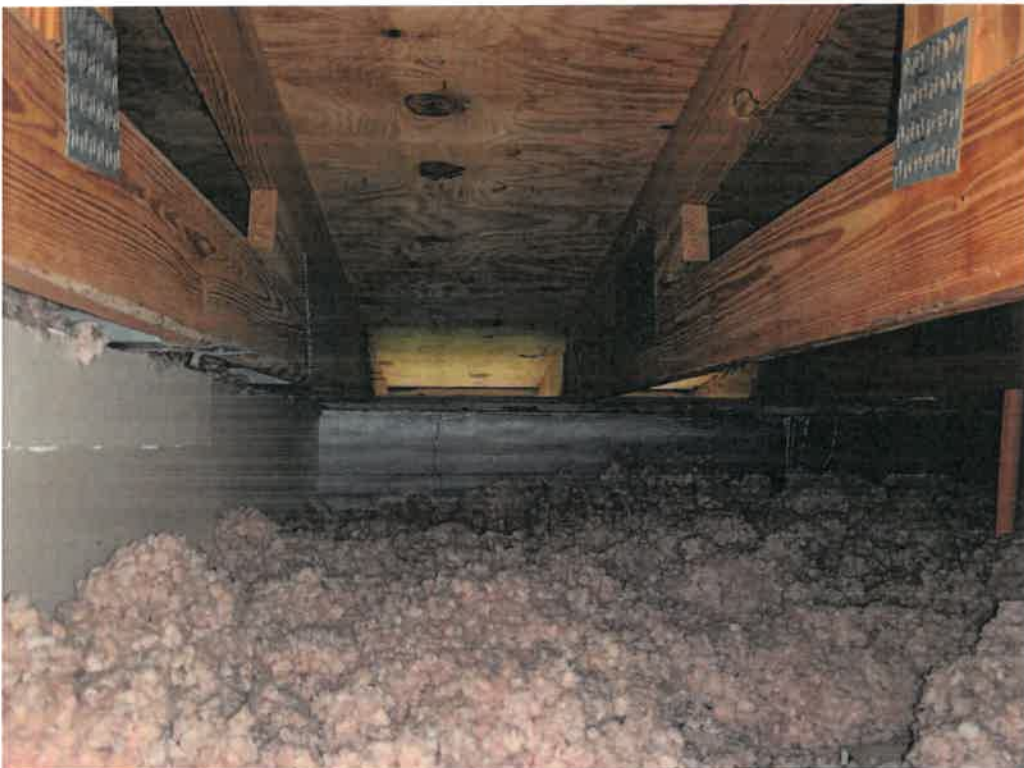
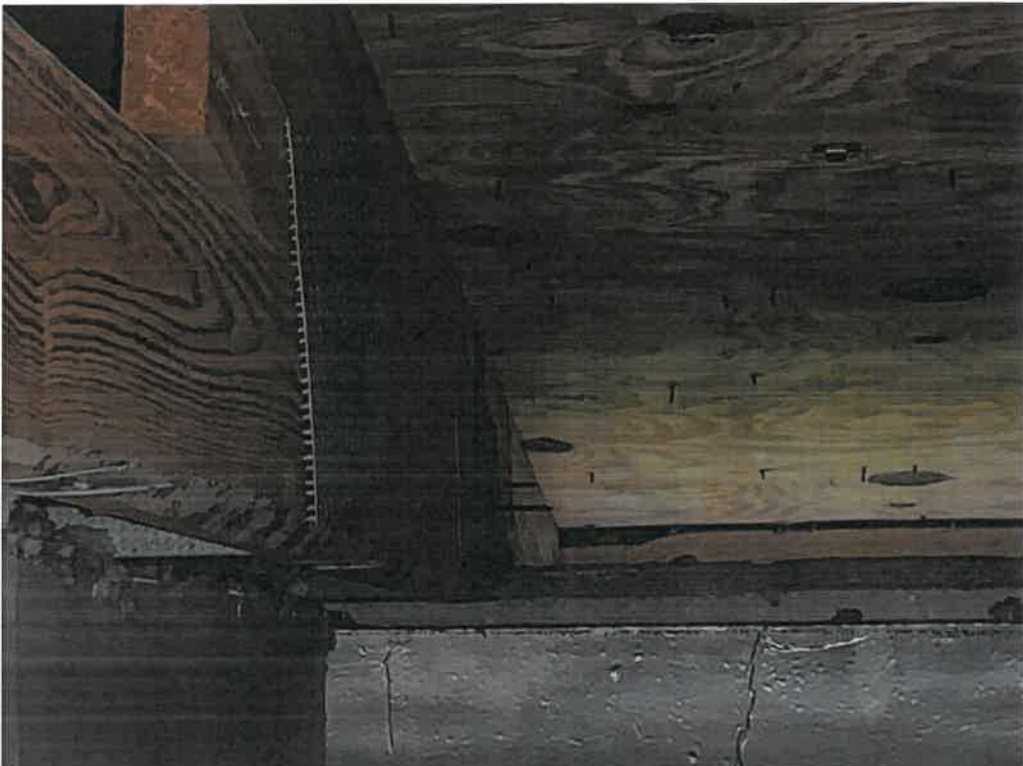
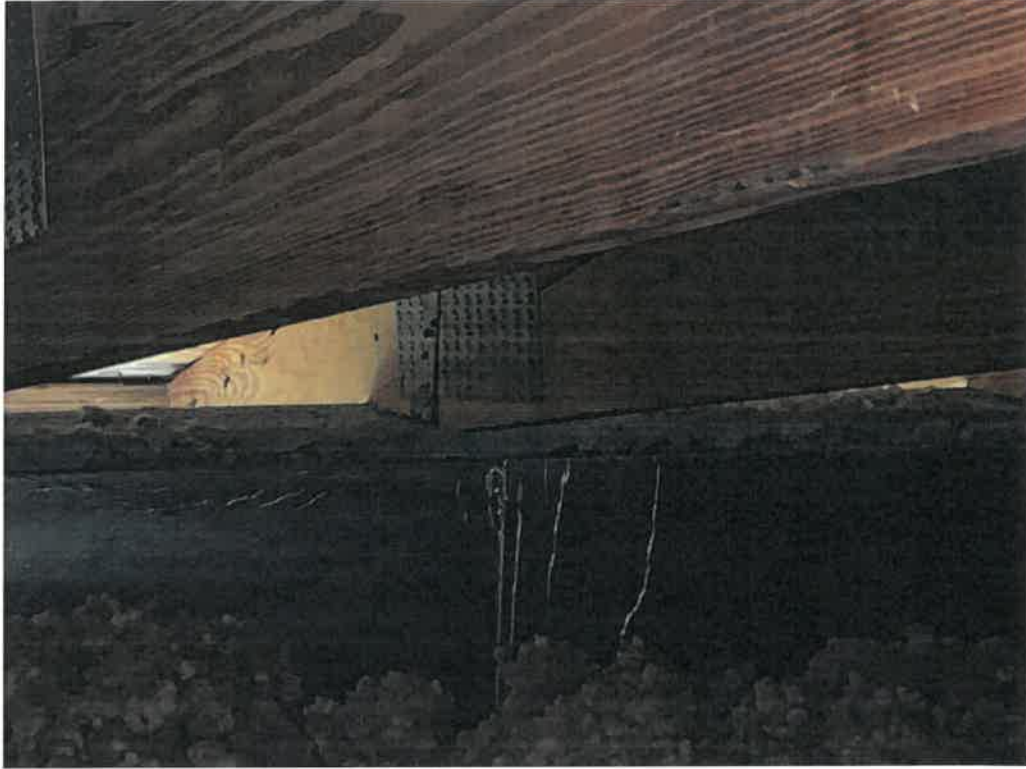
- ☒ Secured to truss/rafter with a minimum of three (3) nails, **and**
- ☒ Attached to the wall top plate of the wall framing, or embedded in the bond beam, with less than a 1/2" gap from the blocking or truss/rafter **and** blocked no more than 1.5" of the truss/rafter, **and** free of visible severe corrosion.

- ☒ C. Single Wraps
  - Metal connectors consisting of a single strap that wraps over the top of the truss/rafter and is secured with a minimum of 2 nails on the front side and a minimum of 1 nail on the opposing side.

**Figure 20: Roof to wall attachment.**

**Figure 21: Roof to wall attachment.**

**Figure 22: Roof to wall attachment.**

**Figure 23: Roof to wall attachment.**
