# Uniform Mitigation Verification Inspection Form

| Inspection Date: 3/2/2023 - 9/6/2023 | | |
| Owner Name: Plaza de Flores Condominium Association, Inc. | | Contact Person: Mark Habermann |
| Address: 4244 Central Sarasota Parkway (B.7) | | Home Phone: |

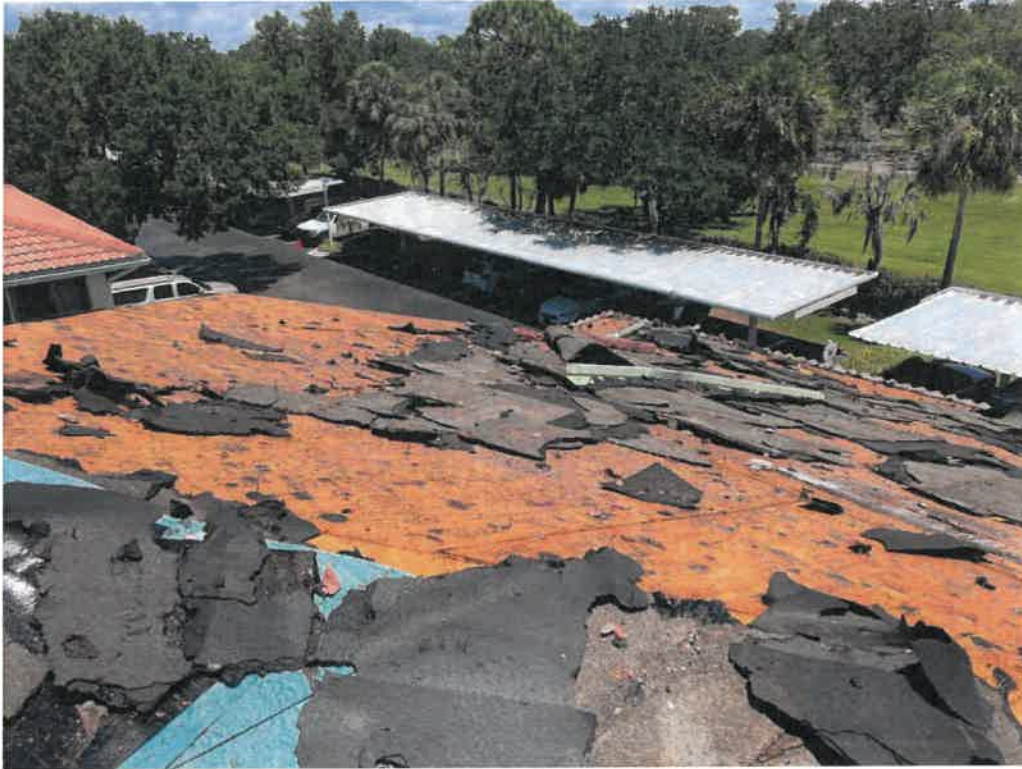
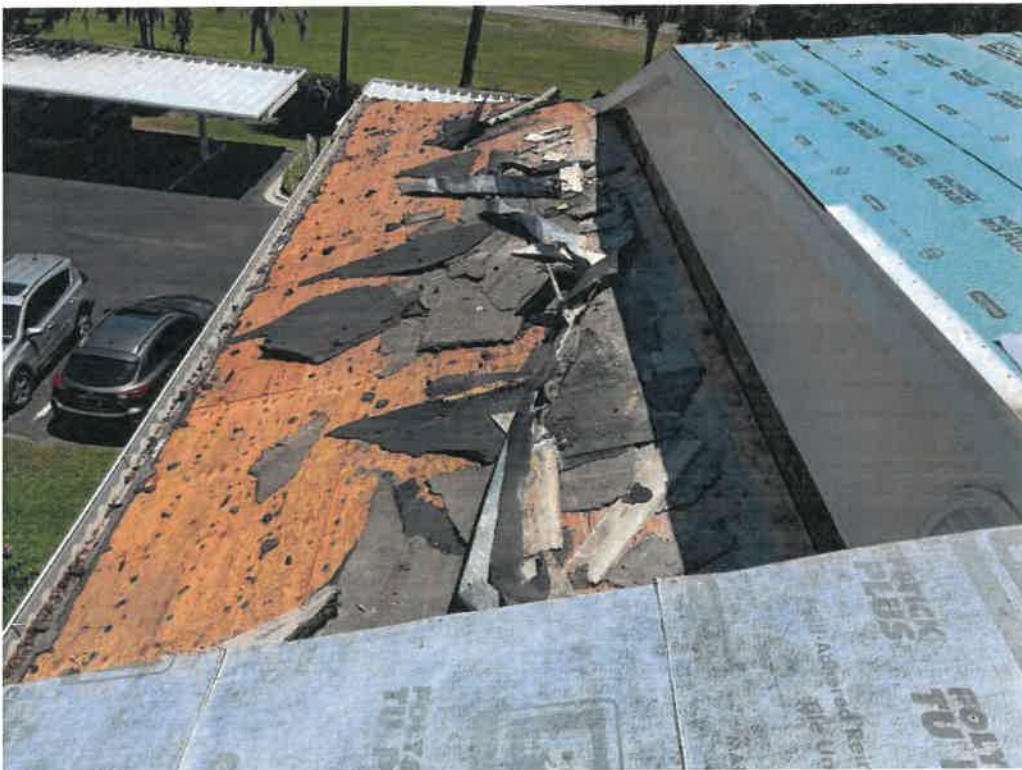
- ☒ C. Plywood/OSB roof sheathing with a minimum thickness of 7/16" inch attached to the roof truss/rafter (spaced a maximum of 24" inches o.c.) by 8d common nails spaced a maximum of 6" inches in the field. -OR- Dimensional lumber/Tongue & Groove decking with a minimum of 2 nails per board (or 1 nail per board if each board is equal to or less than 6 inches in width). -OR- Any system of screws, nails, adhesives, other deck fastening system or truss/rafter spacing that is shown to have an equivalent

or greater resistance than 8d common nails spaced a maximum of 6 inches in the field or has a mean uplift resistance of at least 182 psf.

**Figure 23: Roof to deck attachment.**

**Figure 24: Roof to deck attachment.**
