# Uniform Mitigation Verification Inspection Form

| Owner Name: Plaza de Flores Condominium Association, Inc. | | Contact Person: Mark Habermann |
| Address: 4232 Central Sarasota Parkway (B.8) | | Home Phone: |

| Inspection Company:<br>Karins Engineering Group, Inc. | Phone:<br>941-927-8525 | |

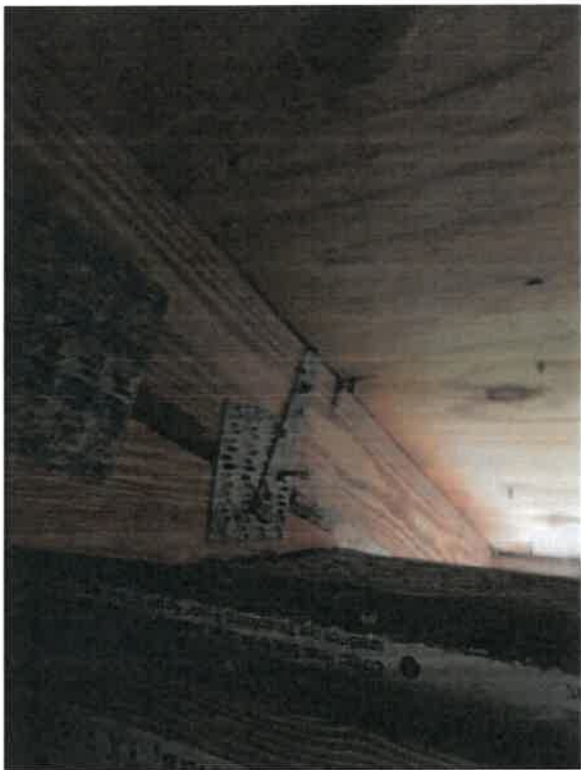
- ☒ Secured to truss/rafter with a minimum of three (3) nails, **and**
- ☒ Attached to the wall top plate of the wall framing, or embedded in the bond beam, with less than a ½" gap from the blocking or truss/rafter **and** blocked no more than 1.5" of the truss/rafter, **and** free of visible severe corrosion.

- ☒ C. Single Wraps
  - Metal connectors consisting of a single strap that wraps over the top of the truss/rafter and is secured with a minimum of 2 nails on the front side and a minimum of 1 nail on the opposing side.

Figure 18: Roof to wall attachment.

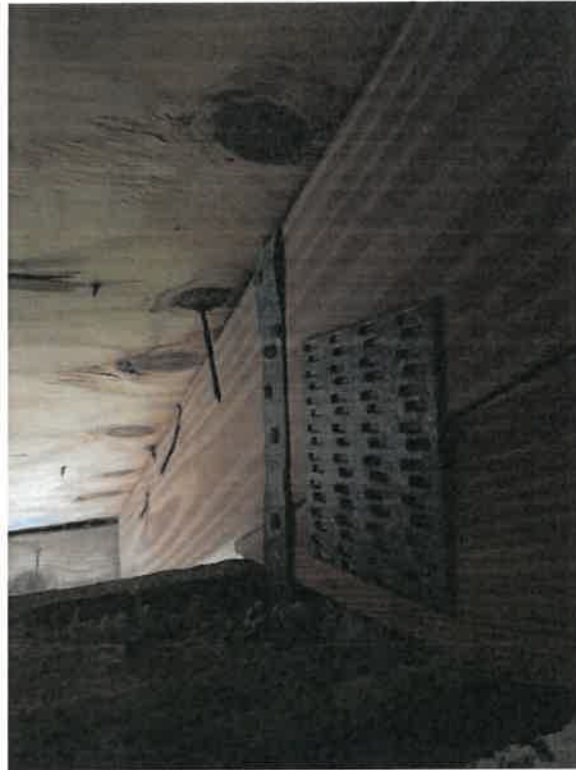
**Figure 19: Roof to wall attachment.**

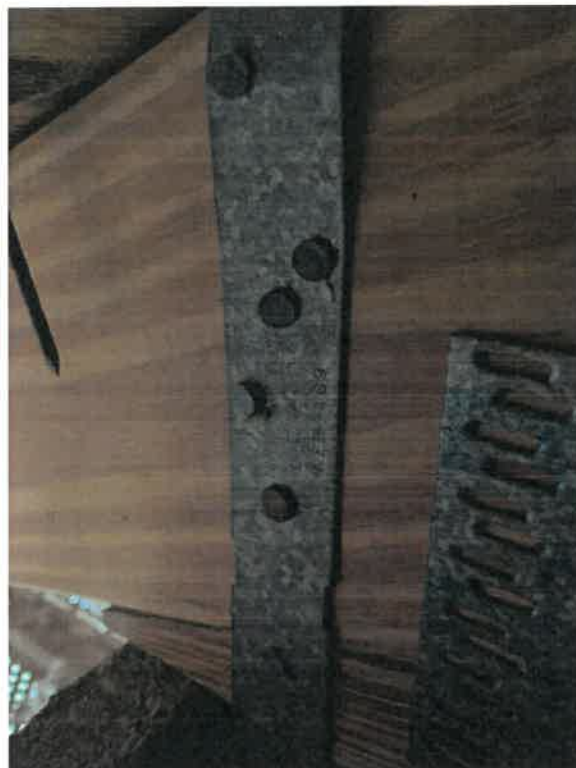
**Figure 20: Roof to wall attachment.**

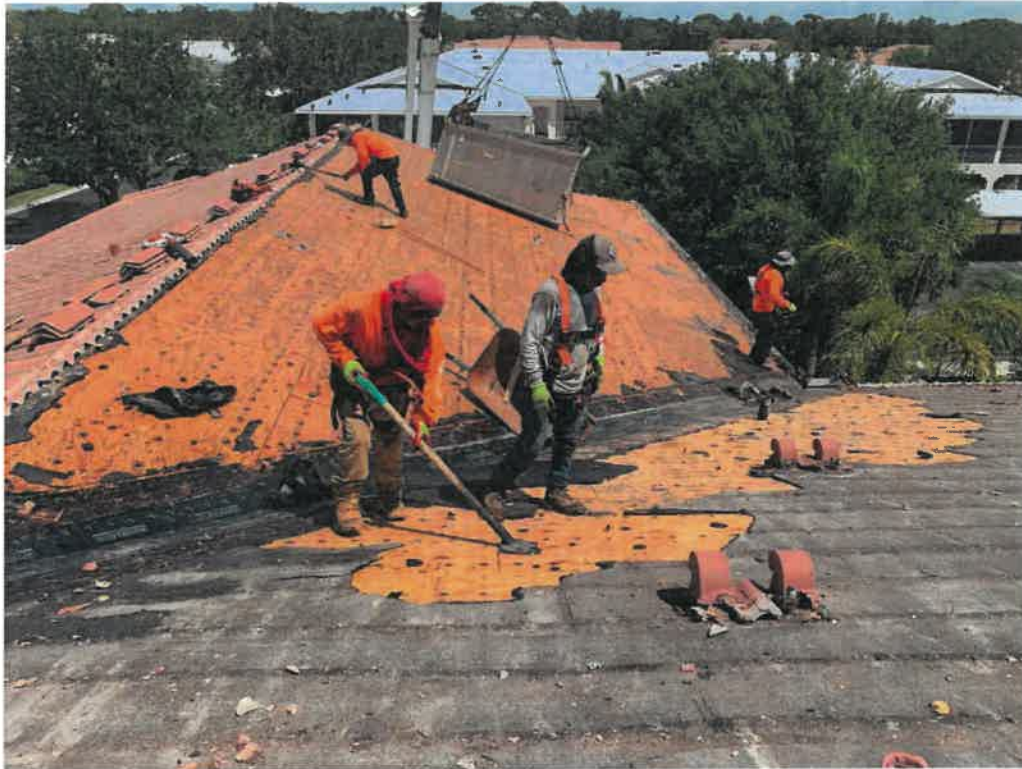
- ☒ C. Plywood/OSB roof sheathing with a minimum thickness of 7/16" inch attached to the roof truss/rafter (spaced a maximum of 24" inches o.c.) by 8d common nails spaced a maximum of 6" inches in the field. -OR- Dimensional lumber/Tongue & Groove decking with a minimum of 2 nails per board (or 1 nail per board if each board is equal to or less than 6 inches in width). -OR- Any system of screws, nails, adhesives, other deck fastening system or truss/rafter spacing that is shown to have an equivalent

or greater resistance than 8d common nails spaced a maximum of 6 inches in the field or has a mean uplift resistance of at least 182 psf.

**Figure 21: Roof to deck attachment.**
